Air Compressor/Water Pump Part IV Pilot Valve Stem, Test & Installation

Nelson Riedel Nelson@NelsonsLocomotive.com

Initial: 1/13/04 Last Revised: 02/23/2006

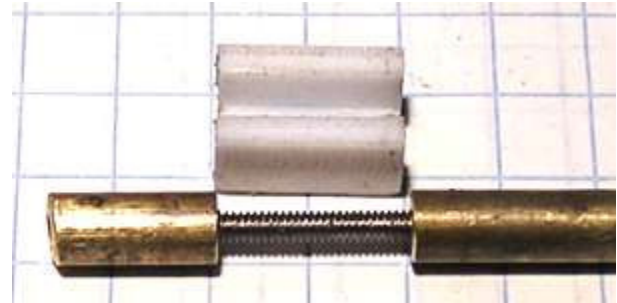
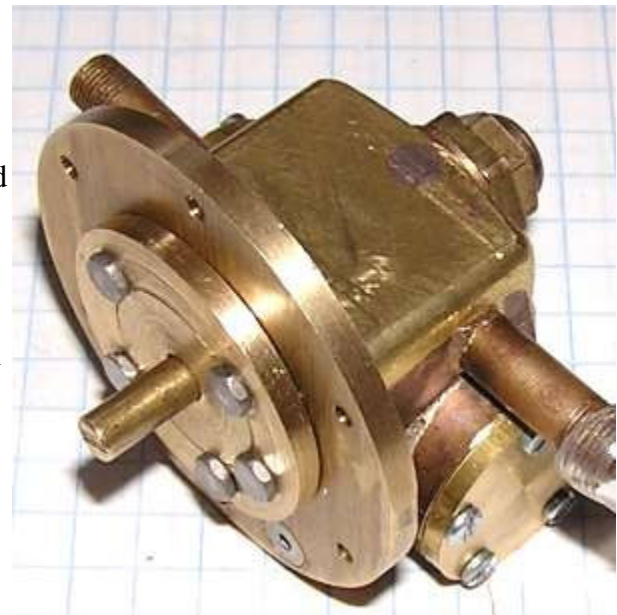
Valve Test: I decided to test the steam valves at this point before going any further with the fabrication. The pilot valve stem assembly in the upper photo was made from 3/16" brass and a 2-56 threaded rod (screw with head cut off). The lower photo shows the valve assembly with the end of one 3/16" brass rod sticking out below the head. Compressed air was then connected via the hose and the valve operation tested by pushing and pulling the 3/16" rod. Well, it didn't work, and there seem to be air leaks everywhere. I took it apart and double checked everything ---- nothing seemed to be amiss. As a last resort I verified that the air was connected to the input port. Damn! Should have checked that first.

Valve Stem: The photo shows the final valve stem. The brass pieces are 3/16" rod. The left piece and left half the middle piece are threaded 2-56, the screw on the left and the stainless threaded rod over the valve are also 2-56. The stainless steel piece on the right is 1/8" OD threaded 5-40 on the ends. The screw in the right end is 4-40 stainless steel. The disk screws to the top of the steam piston.

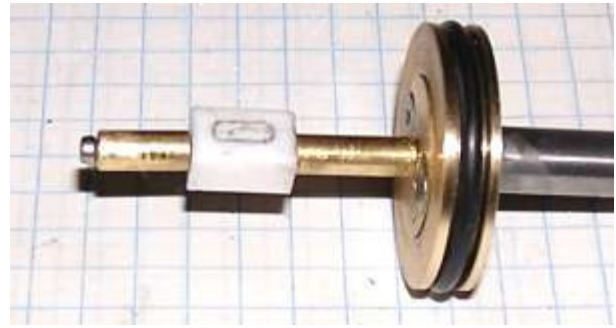
This photo shows the valve stem position when the the piston is against the stops at the top of its travel. The middle brass piece was cut to the exact length required so that the valve is positioned in the upper extreme position. The screw on the left is cut so that it's all the way in and against the end of the 2-56 threaded rod. The

valve is loose in the gap between the two brass pieces.

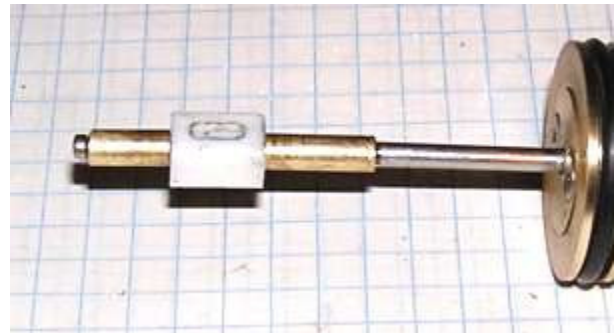
This shows the valve stem position when the piston is against the stops at the bottom of its travel. The brass piece inside the piston rod was adjusted so that the valve was in the lower extreme position. The screw in the right (lower) brass piece was then cut so that it was all the way in the brass piece and against the end of the 1/8" rod. After the pump was tested and the valve stem adjustment was shown to be correct, #620 (high temperature) Loctite was applied to all the threads except the joint between the brass piece inside the piston rod and the 1/8" rod.

Update 5/16/04: The pump failed several times due to the pilot valve rod and the connection between the shuttle valve pistons working loose. I finally bit the bullet and took apart each joint and applied high temperature Loctite (620) which seems to have fixed the problem. **End update.**

The valve stem is removed by inserting a hex wrench up through the lower end of the piston rod and blade screwdriver down through the top of the pilot valve cylinder into the screw head above the valve. The joint inside the piston rod can then be unscrewed and the stem with the valve can then be pulled up and out of the top of the pilot valve cylinder.

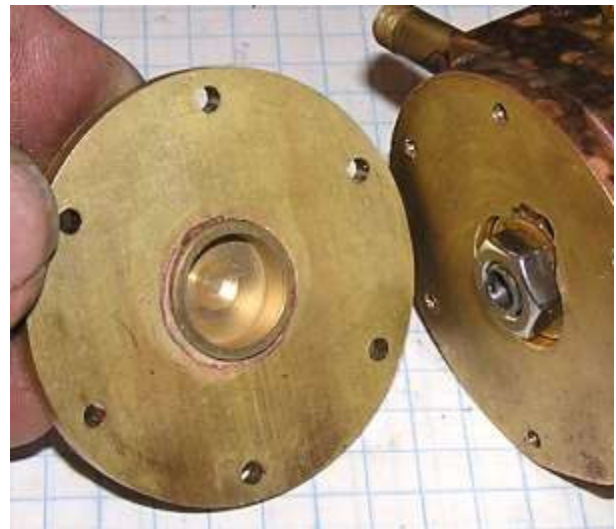
Lower Head: The lower head on the water pump was the last operational part to be finished. A piece of 3/4" Brass rod was turned to fit inside the pump cylinder (5/8" OD) and a recess bored to accommodate the the nut on that holds the pump piston to the piston rod. This piece was then silver soldered to the head. The photo shows the head with with the short (~.030") shoulder that fits into the pump cylinder.

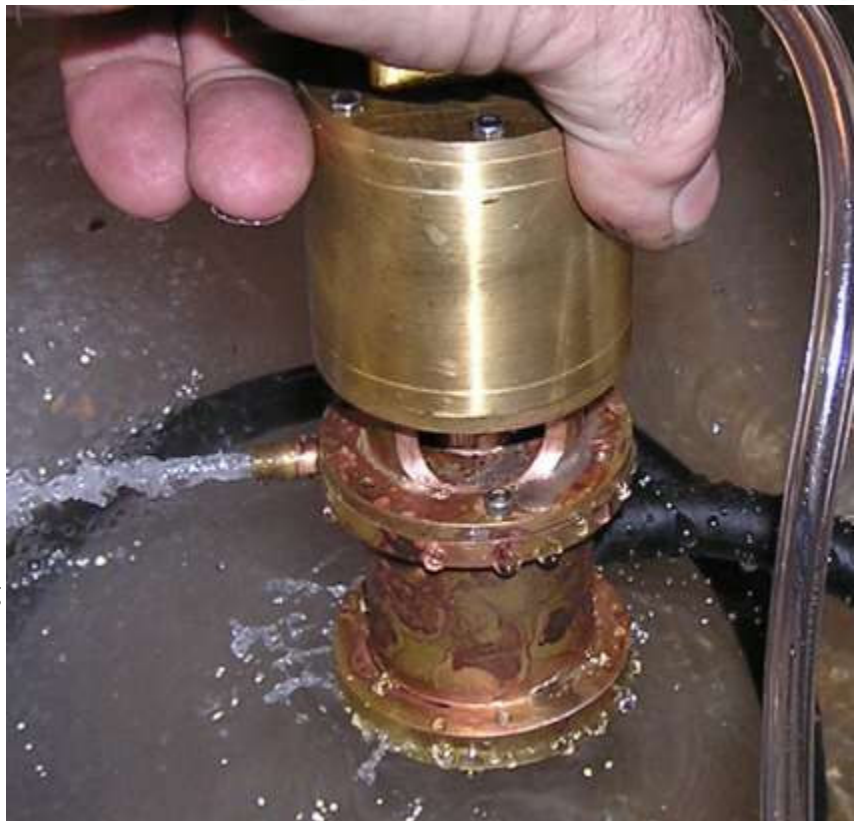
It Works! Everything was assembled for a test of the complete pump. The unit seemed very stiff so a few drops of silicone brake fluid was added to the air line ---- it seemed to work even better than with the glycol based fluid. Next the sink was partially filled with water, a hose connected to the water input with the other end in the sink. The air was connected and the pump started up. The output sputtered for a couple seconds and then shot a stream about 20 foot across the room. (Fortunately I was using the workshop sink; she'd have killed me if she caught me doing something like this in her kitchen sink.) About as much water came out around the pump heads as the output pipe. The heads were attached with only two screws.

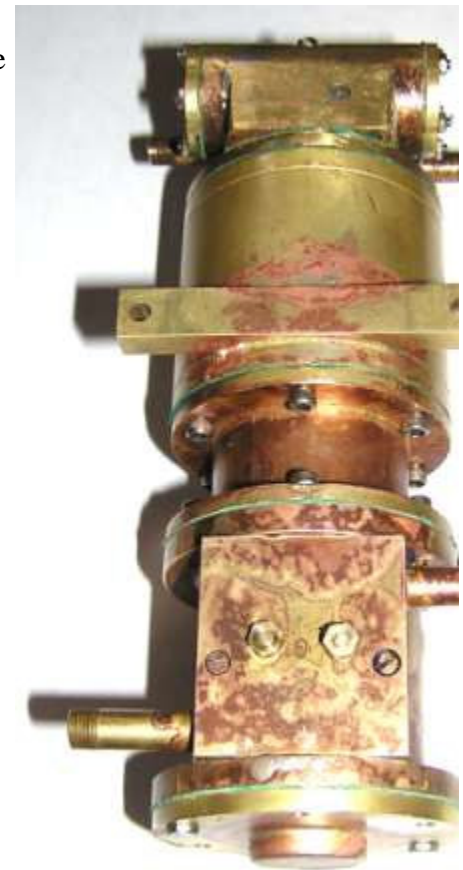
Mount: The last major task was to make the mount. A 3/8" wide slot was milled in the back of the steam cylinder and the 1/4" X 3/8" mounting bar was soldered in the slot. The holes in the ends of the mount are for 6-32 screws.

Gaskets were then made for the cylinder heads, shuttle valve heads

and between the upper head and the steam valve assembly. The shuttle valve head screws were replaced with studs and nuts. All the head screws were then installed and the pump tested again. The gaskets and screws seemed to fix the leaks.

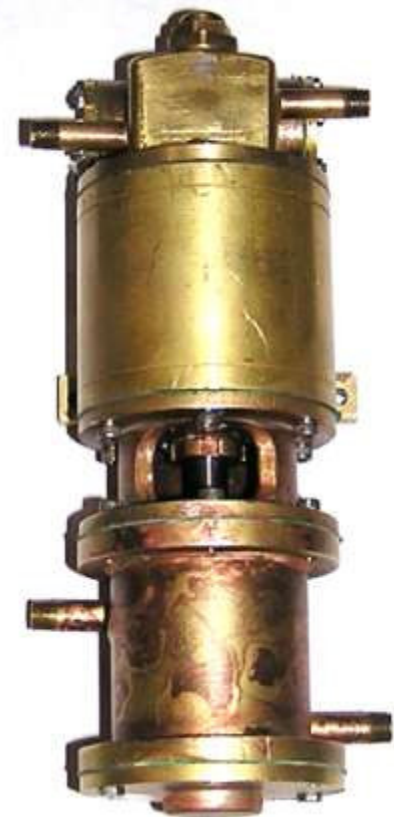
This shows the finished pump. The pump will have to be partially disassembled later to install the correct EPDM O-Rings on the steam cylinder piston and for the valve stem seals. The socket head cap screws connecting the tie piece to the two cylinders will be replaced with hex head screws at that time. The socket head screws are easy to install and remove using a ball end hex wrench which was convenient when multiple assemblies and disassemblies were required during the fabrication. The hex head screws are more time consuming to install since an open end wrench is used.

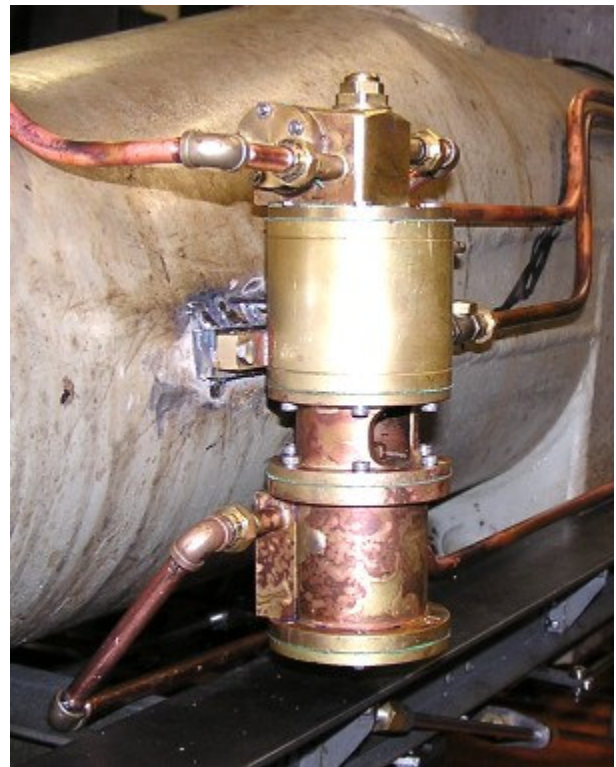
Installation: A 1/2" wide 1/4" thick steel mounting plate was welded to the boiler. The pump mounting bar screws to the mounting plate. The pump is positioned lower than the pump on Cass 5 because the steam pipes are higher than on the Westinghouse unit. The pump didn't look right when positioned about an inch higher as on Cass 5. The front top pipe is the steam exhaust that goes over the smoke box and down to the engine exhaust pipe. The lower front pipe is the water pump output that goes to the inside of the frame I beam and then down under the left mud ring and then under the cab floor where it ties into the hand pump output.

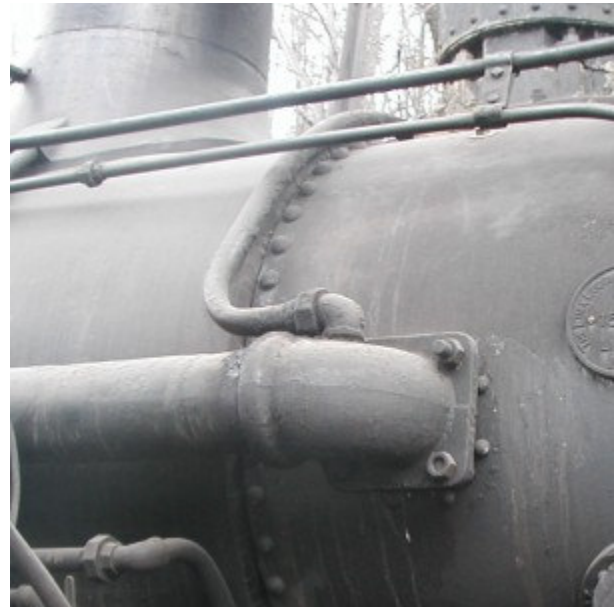
I dug out this photo of Cass 5 to show how the pump steam exhaust goes over the top of the smoke box and down to the engine exhaust pipe. This is a color photo but the color is wasted on this object.

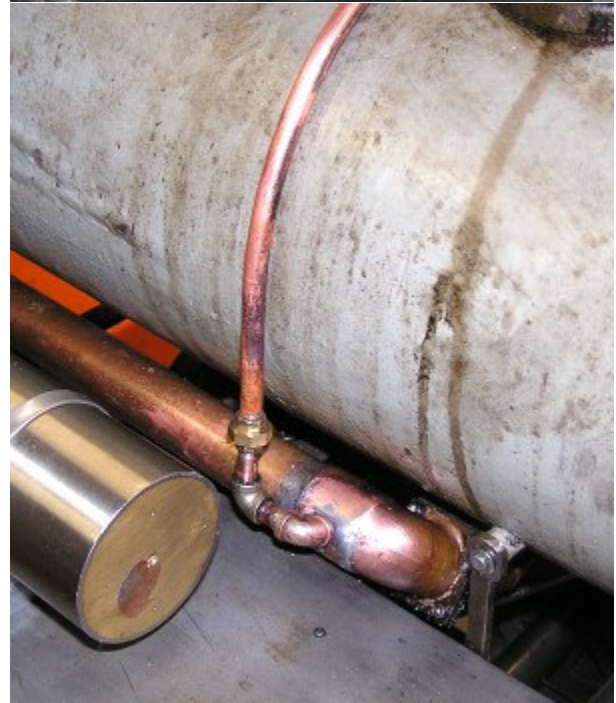
This shows how the pump exhaust is connected to the engine exhaust pipe. The street elbow is screwed into the exhaust pipe and then soldered using 550 degree soft solder to make a solid connection.

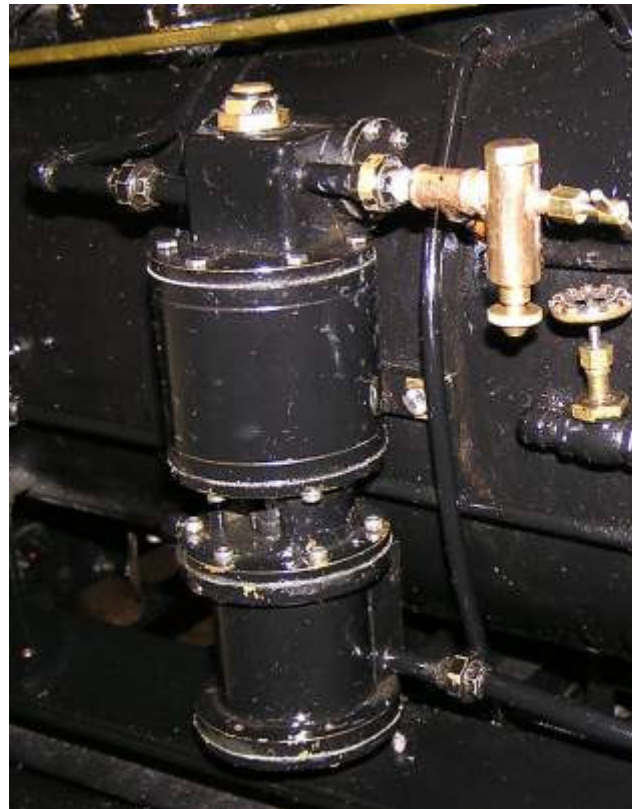
Update 2/23/2006: As mentioned previously, the EPDM O-Rings became sticky after a couple years of use so I changed to Viton O-Rings on the steam piston, steam valves and rod seals. I also added the displacement lubricator shown on the right. The lubricator was obtained from American Model Engineering Supply, model DLU4. The unit seems to run a bit freer than before.
