Shay - Boiler Cosmetics - Part II

Initial:3/04/04 Last Revised: 06/06/2004

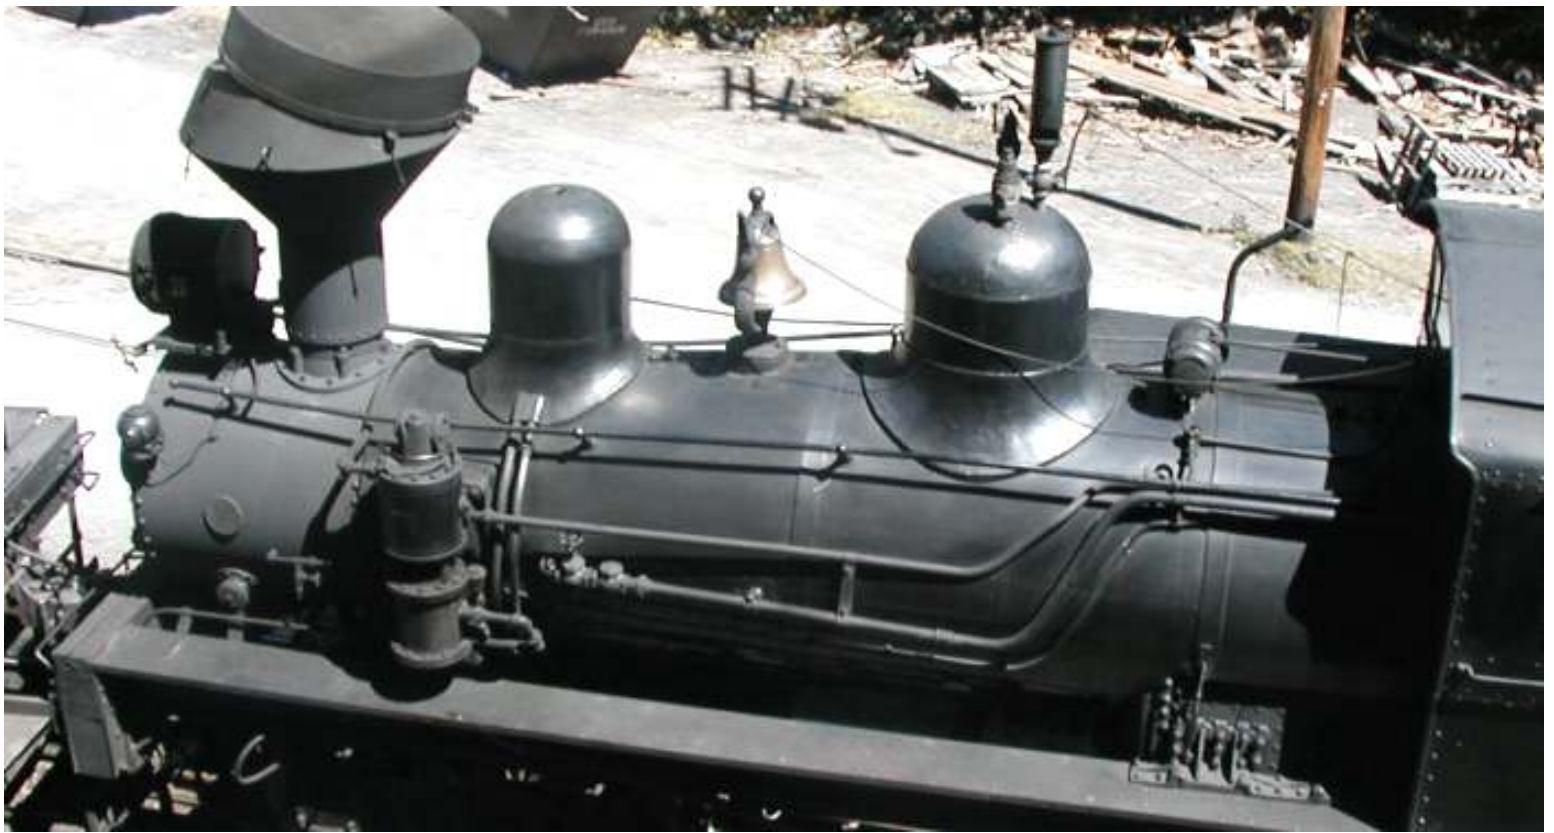
The task here is to do the jacket and bands. The following photo of Cass 5 jacket and bands is repeated here to keep the goal in mind.

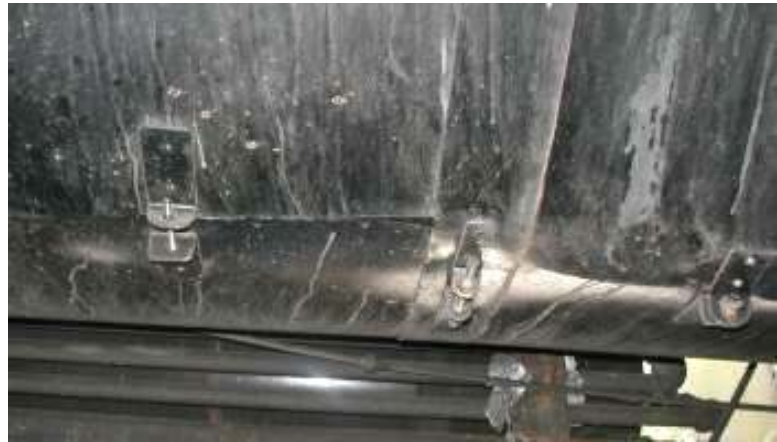
The photo on the right shows how the jacket and bands are fastened on the underside of the boiler.

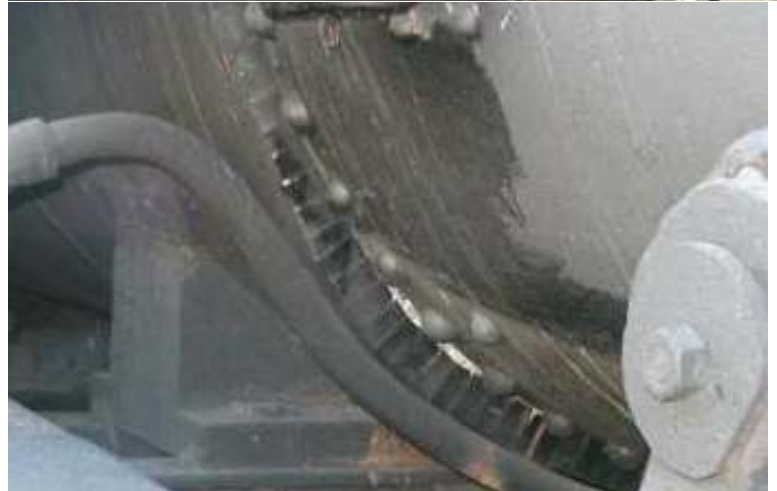
This photo shows the front edge of the jacket. Note that the jacket is slit and then bent over to cover the front edge of the lagging.

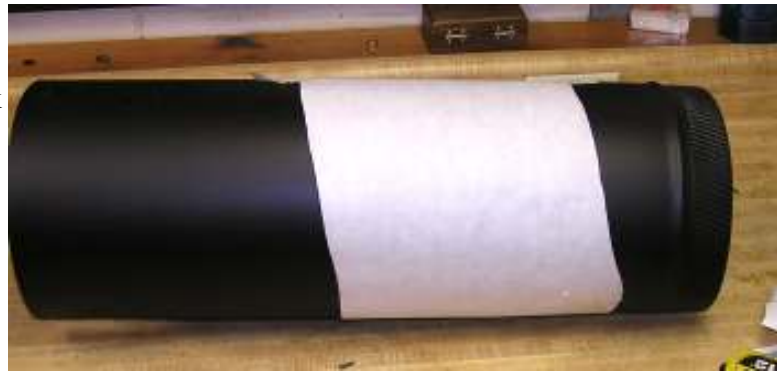
Jacket: I'd been dreading the jacket for months ---- hate to work with sheet metal. Decided to bite the bullet and start with the jacket over the forward sloped section. Kenneth suggested black stove pipe. Obtained some 24 gauge 8" diameter at local hardware. The photo shows a rough heavy paper pattern taped to a section of stove pipe.

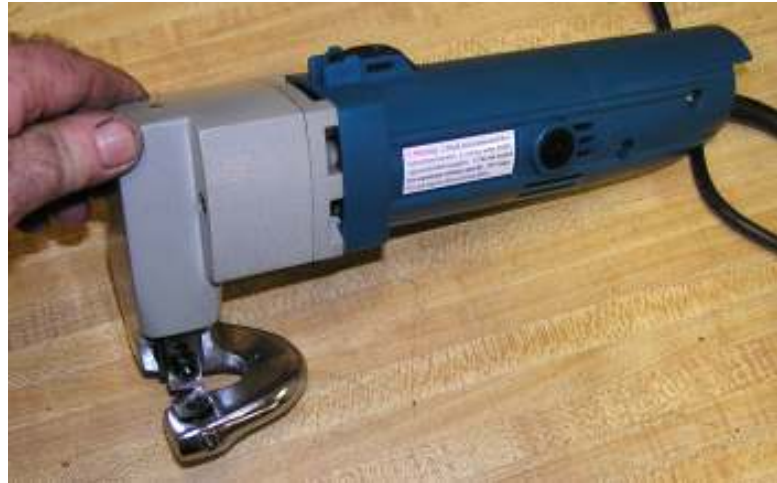
Tried to cut the stove pipe with my old snips ---- what a chore ---- that's why I hate to work with sheet metal. Found that the local Harbor Freight store had the power shears shown in photo on sale for \$30. They cut that 24 gauge like a hot knife through butter.

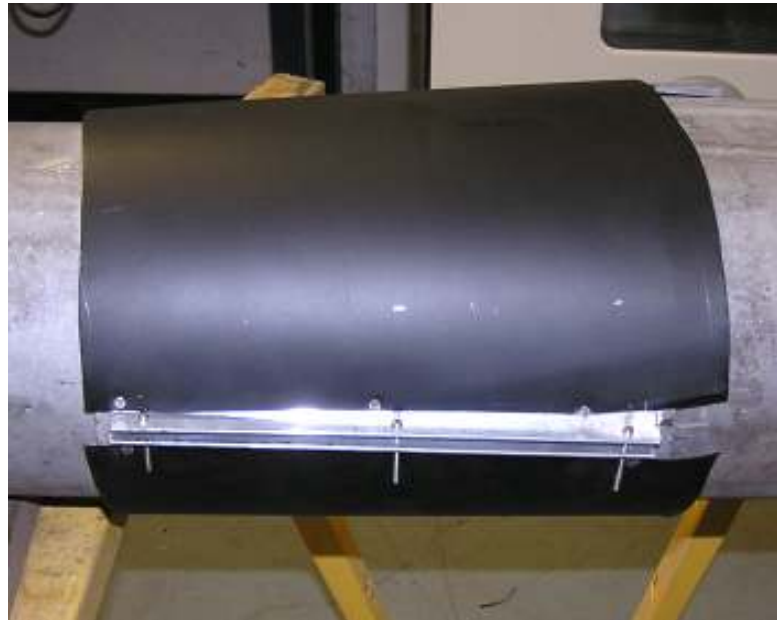
The 8" OD pipe was about a half inch too short but the gap will be filled with the legs of the 1/16" X 1/2" X 1/2" angle fastened to the bottom joint. The photo shows the initial positioning of the piece. After the angles were tightened there was some slack so the angles were moved back on the pipe.

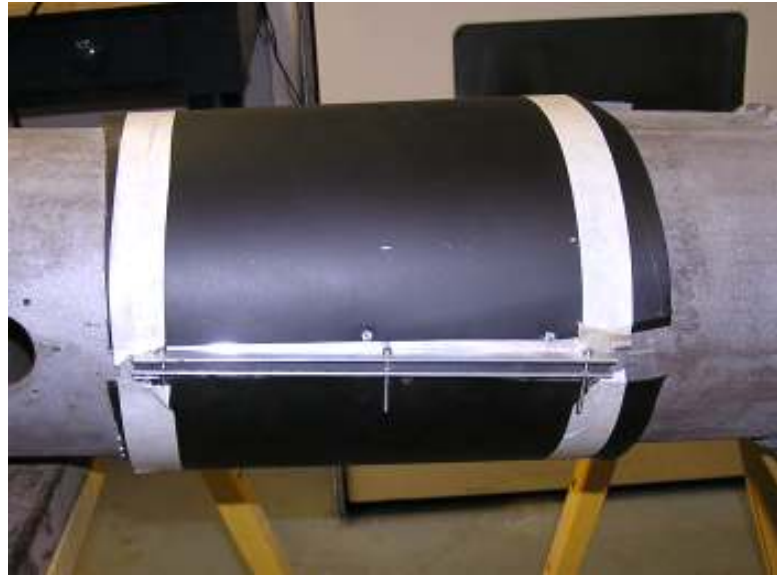
This photo shows the piece positioned properly. The fit was very good. The tape is to mark the edges for later trimming. The power shears were used to trim the edge close correct position. The edge was then finished with a file to bring it even with the front edge of the spacer.

At this point the piece had been off and put back on so many times that a zipper or Velcro straps looked like a better alternative.

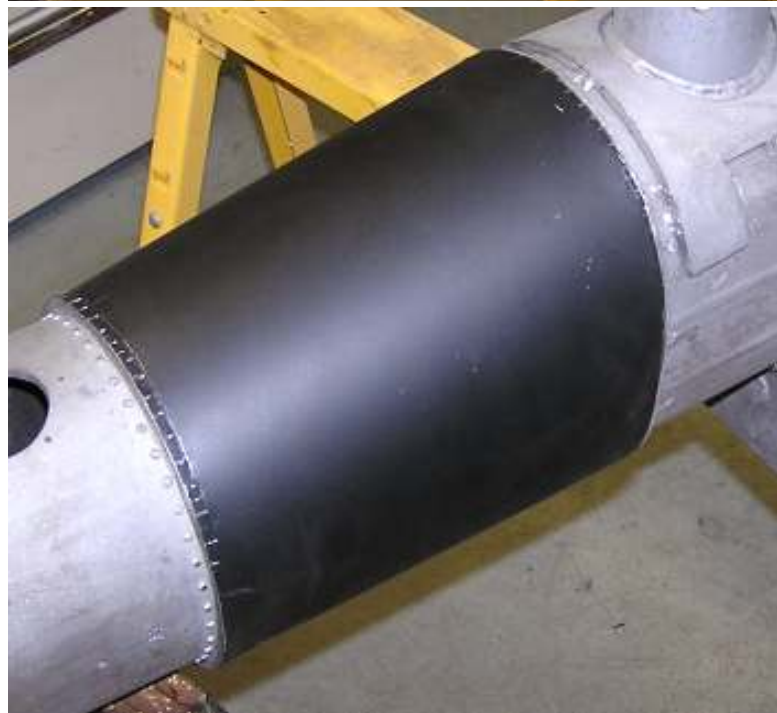
This shows the trimmed edges. The jacket is flattened over the spacers so that the bands will lay flat. The edges of the sloped section were slit about every half inch to relieve the bend. Slitting with hand shears were tried first but the gap was too narrow to make much relief and the shears marked the jacket beyond the slit. What worked best was to make the slits using a Dremel abrasive cutoff disk. After all the slits were made the edges over the spacers were pounded flat.

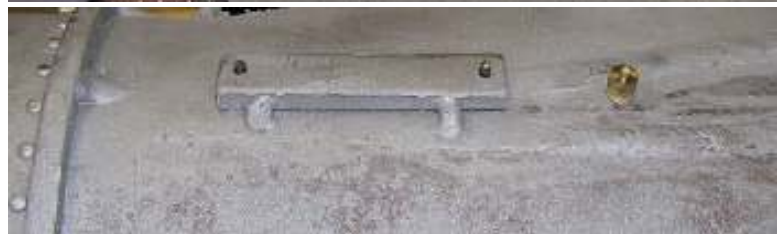
Sort pieces of 3/23" rod were inserted in the pump mounting holes and a hole drilled in the plug in the left feed water hole as show in the photo. The rods were used to mark the holes to be drilled in the jacket.

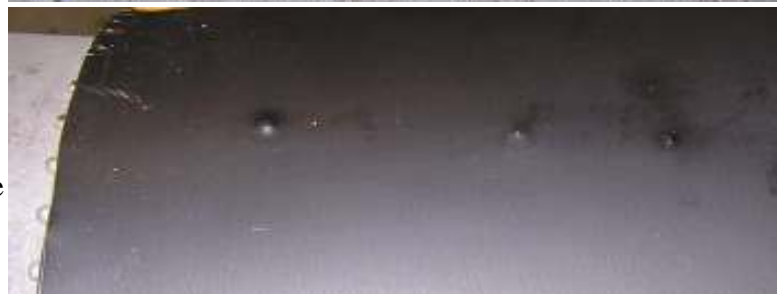
The jacket was reinstalled and positioned properly and then a wood block was placed over the jacket in the area of the holes and then the block was hit with a hammer. The photo shows the resulting dimples. These holes were drilled. The same technique was use to locate the feed water hole on the other side.

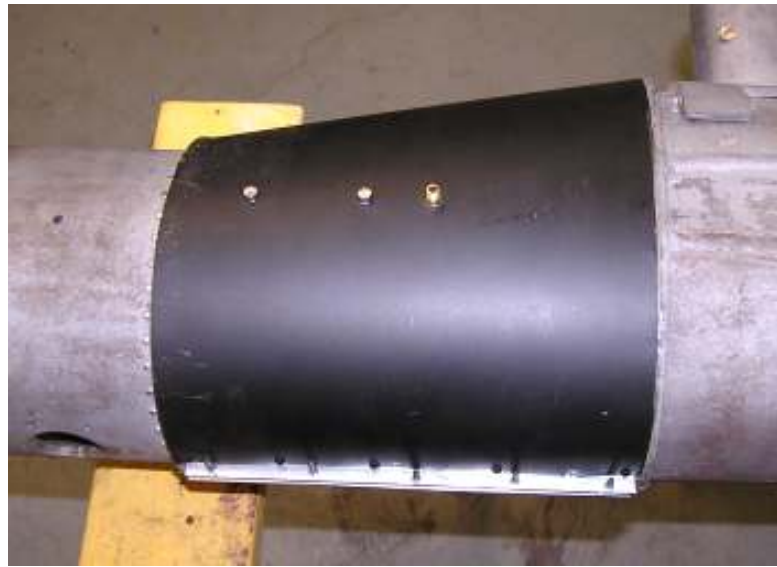
The final step was to mill the protruding leg of the angles to 3/8" and then add a few more screws holding the angles to the jacket and also between the angles. The jacket is really tight and smooth ---- like a drum. It wasn't so bad after all.

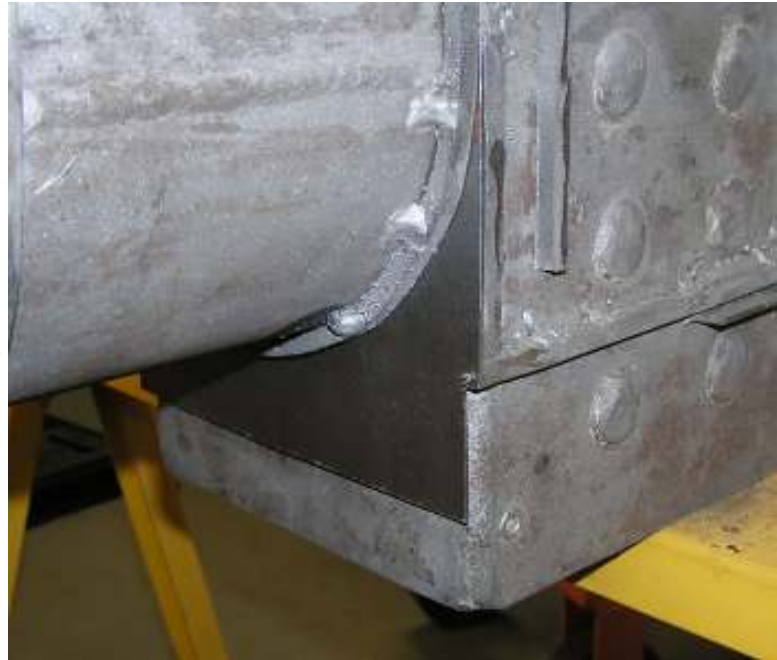
Before making the middle jacket section a piece of of ~ 0.050" steel was cut to cover the part of the firebox visible above the frame. The piece is positioned behind the spacer as shown in the photo. There is a #2 screw on each side to hold it in place.

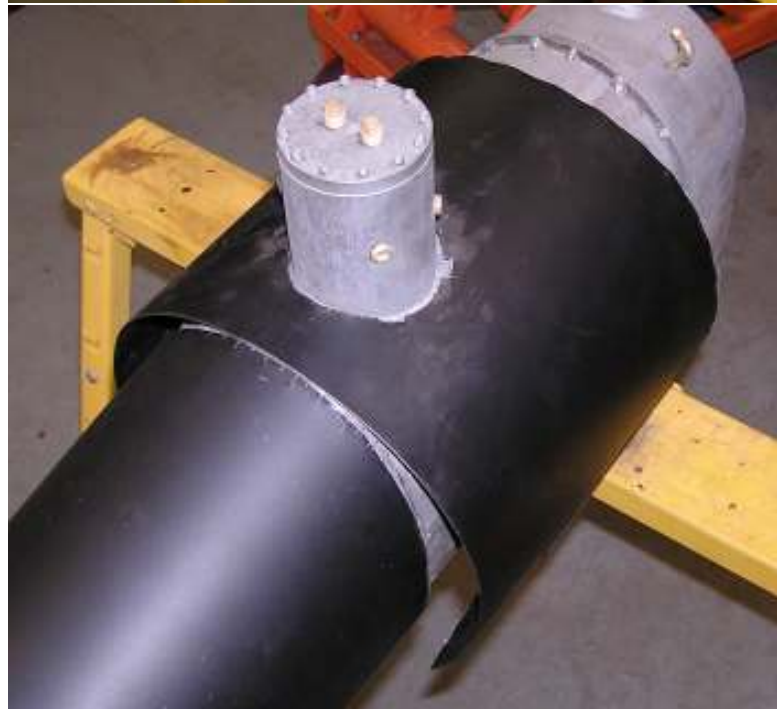
The middle section was next. The hole for the steam chamber was cut with a Dremel abrasive cutoff disk. The hole was then trimmed with a hand nibbler.

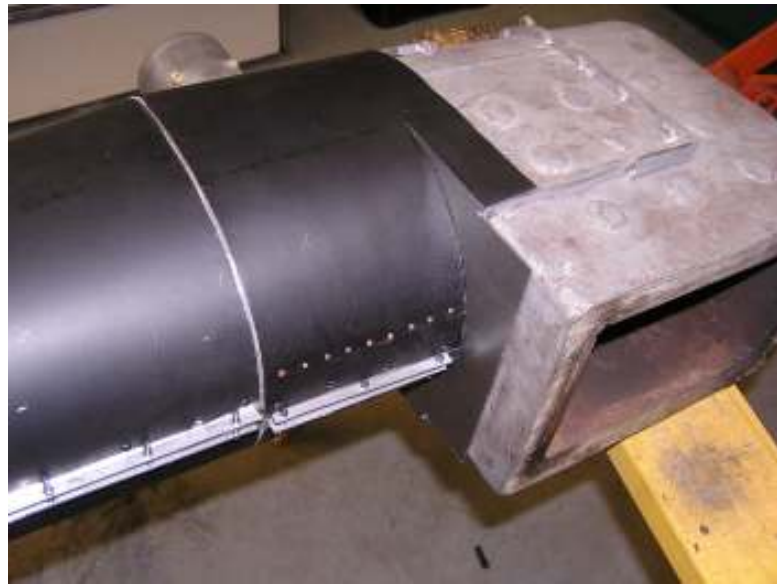
This photo shows the the nearly finished middle section. Note that a ~1" piece was added to make it large enough. The only critical step was to keep the slit up each side straight and to end it at the proper point. The cuts were made with the power shears with good results.

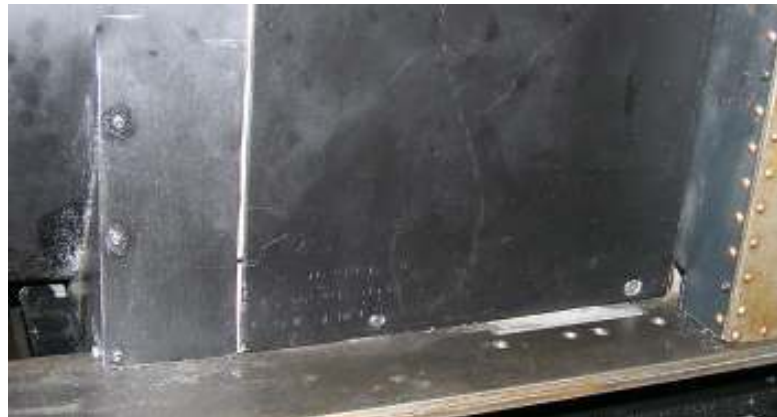
On To The Last Jacket Section: A section of stove pipe was cut to a length that left a small gap between the middle and rear sections. This will allow some adjustment if necessary to keep the rear edge of the jacket against the front of the cab. The manufactured pipe edge was positioned against the cab front. The left side was secured to the spacer with two #2 screws as shown in the photo. The rear screw is a flat head because it is behind the boiler clamp.

The holes for these two screws were elongated front to back to permit some adjustment of the jacket.

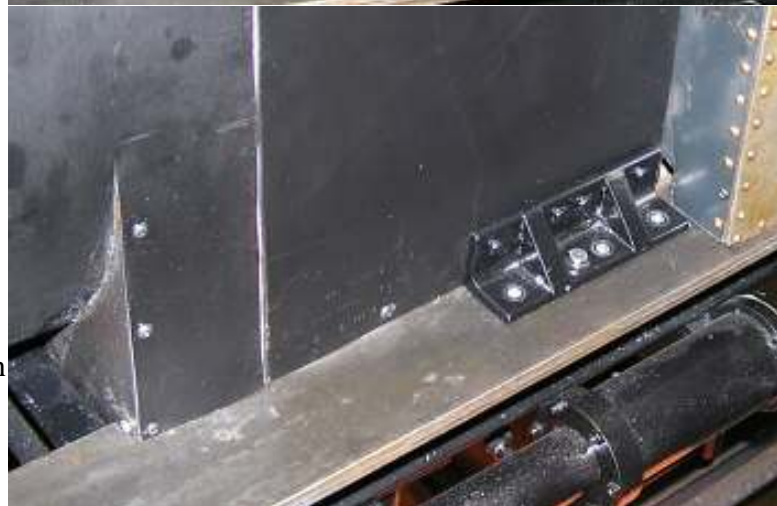
This photo shows the boiler mount clamp temporarily in position. Note the slit in the cab front for the input water pipe to the air compressor/pump is behind the clamp. The pipe will have to be raised a little to clear the clamp.

Note that edge of the middle jacket section has been secured with three #1 button head screws.

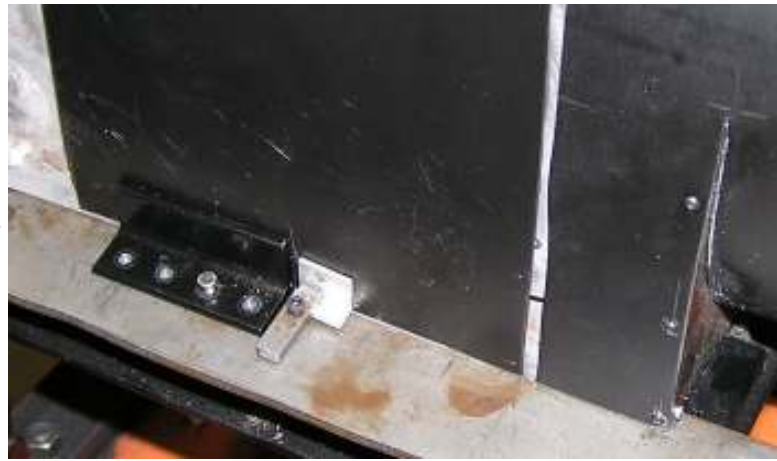
This photo shows the right side of the rear jacket section. The piece of aluminum angle was attached to the jacket with a screw. The little clamp allows the jacket to be adjusted front to back if necessary so that there is no gap between the rear edge of the of the jacket and the front of the cab.

This side of the jacket is hidden behind the engine.

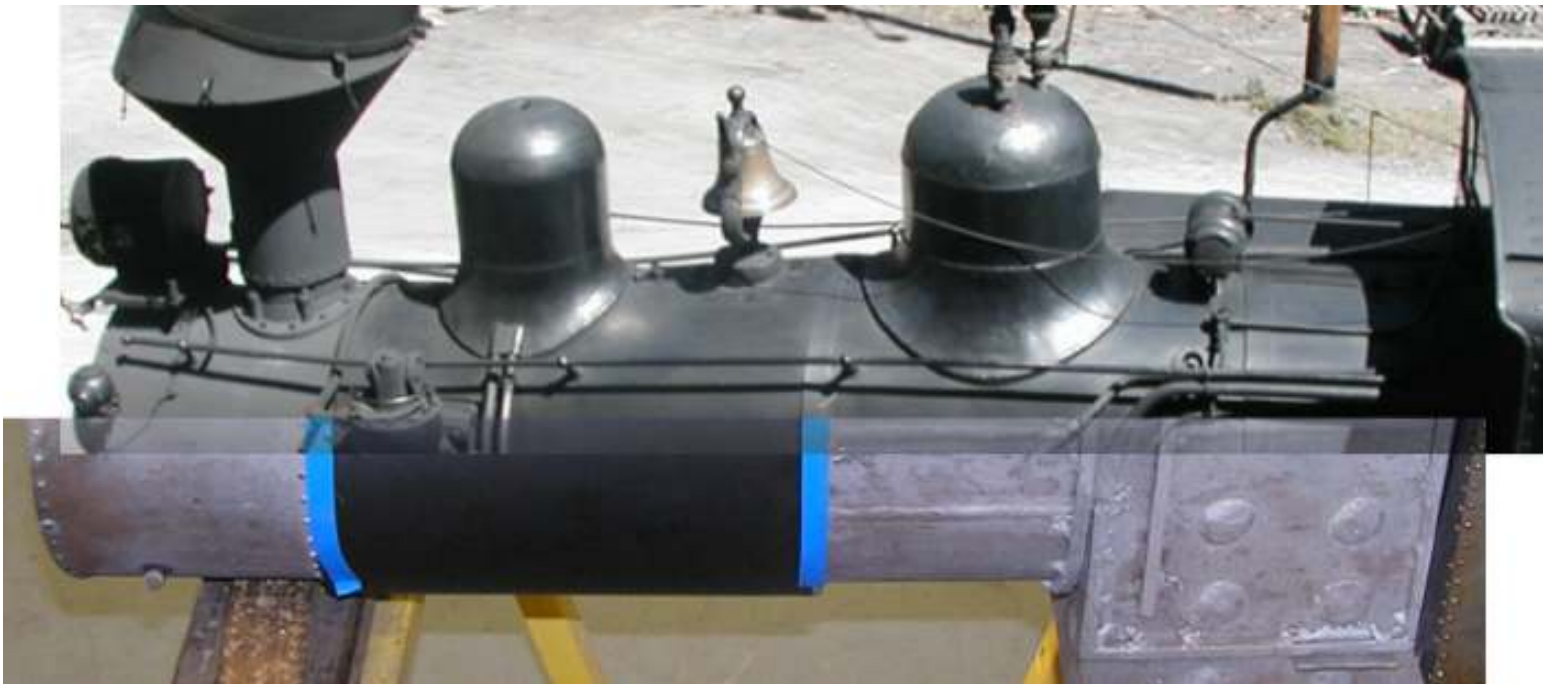
Bands: Before starting the rear jacket section described above, brass strips were ordered for the bands. The first thought was to use 1/4" wide strips. However, review of some Cass photos suggested the bands were wider. Measurements of the bands on the photos and some calculations indicated the bands are about 2 inches wide, which would scale to 1/2". As a double check, 1/2" strips of blue masking tape were put on the model, a photo taken and then edited so that the boiler length was the same length as the boiler in a photo of Cass 5. The two photos were overlapped and positioned so that a band and a piece of tape lined up. The following is this combined photo. The bands indeed should be about 1/2" wide. However, I think the tape looks too wide. I ended up ordering 3/8" wide bands and a couple pieces of 1/4" and 5/16" in case I want to use a narrower band on the front. The bands came from Special Shapes.

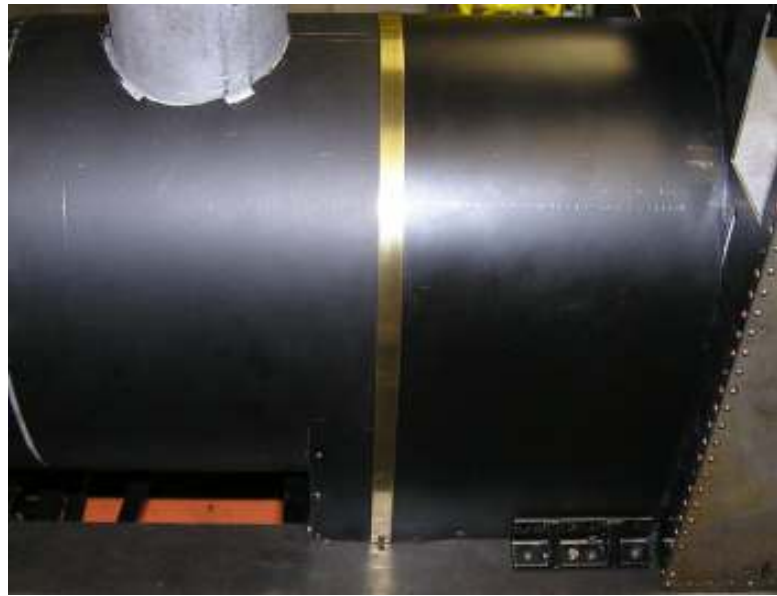
The rear band was made first since the the boiler was in position on the frame. The left side was secured with a #2 button head screw as shown in the photo. .

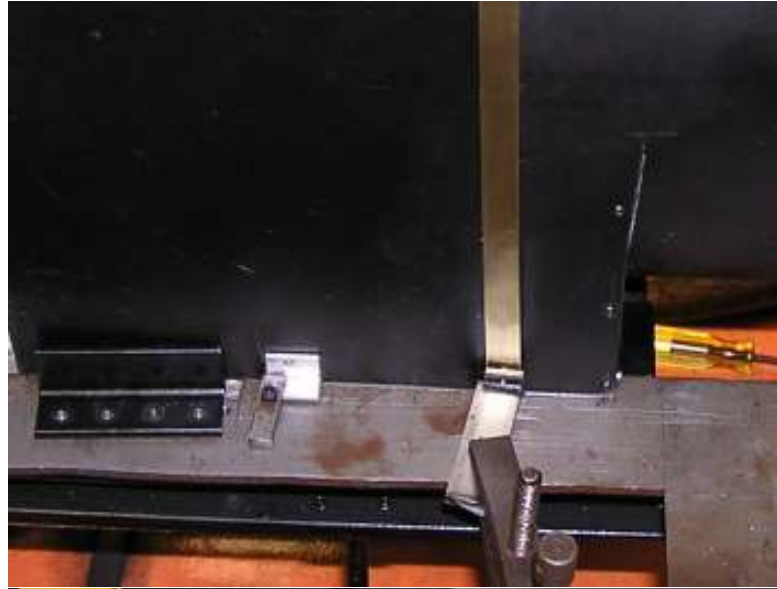
The photo shows the right side, which was equipped with a small angle similar to the rear jacket section. A screw with clamp to hold down the band angle will be added after the boiler is removed (making it easier to drill and tap the hole).

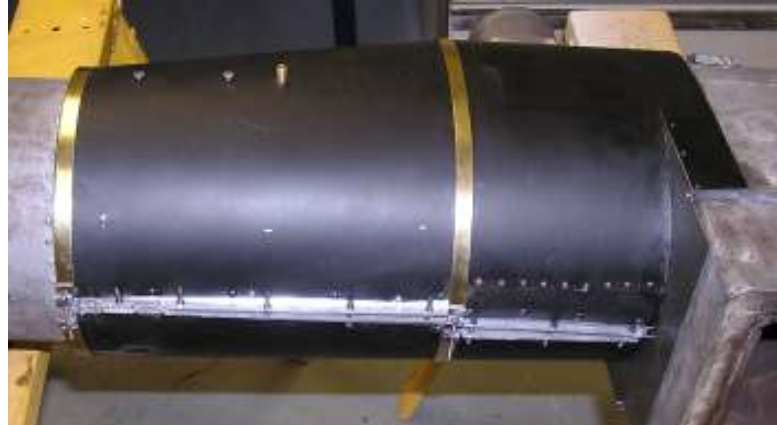
Each end of the middle and front bands were equipped with small angles. Screws through the angles closed the bands. The photo shows the under side of the boiler. None of this is visible from the side of the locomotive.

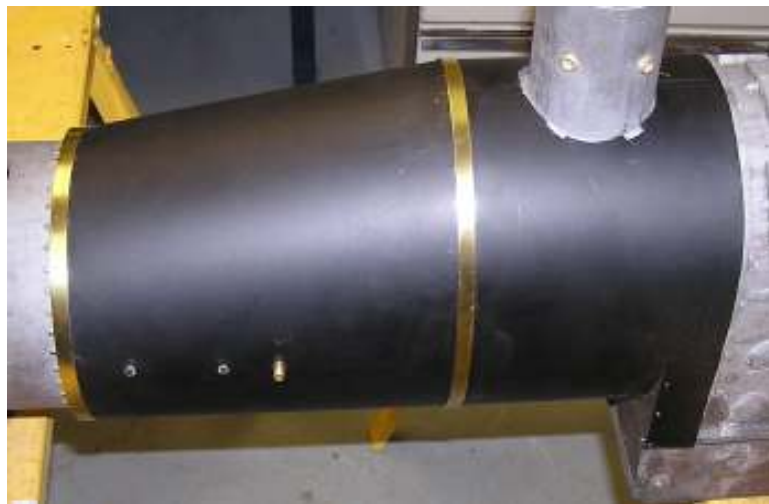
This photo shows the middle and front bands in place. All three bands are 3/8" wide.
