Shay - Painting & Assembling The Boiler

The goal here is to:

- Paint the boiler, jacket, bands and walkways
- Apply lagging to the boiler
- Install jacket and bands on the boiler.
- Install blower and associated exhaust fitting to bottom of smoke box
- Install boiler in frame.

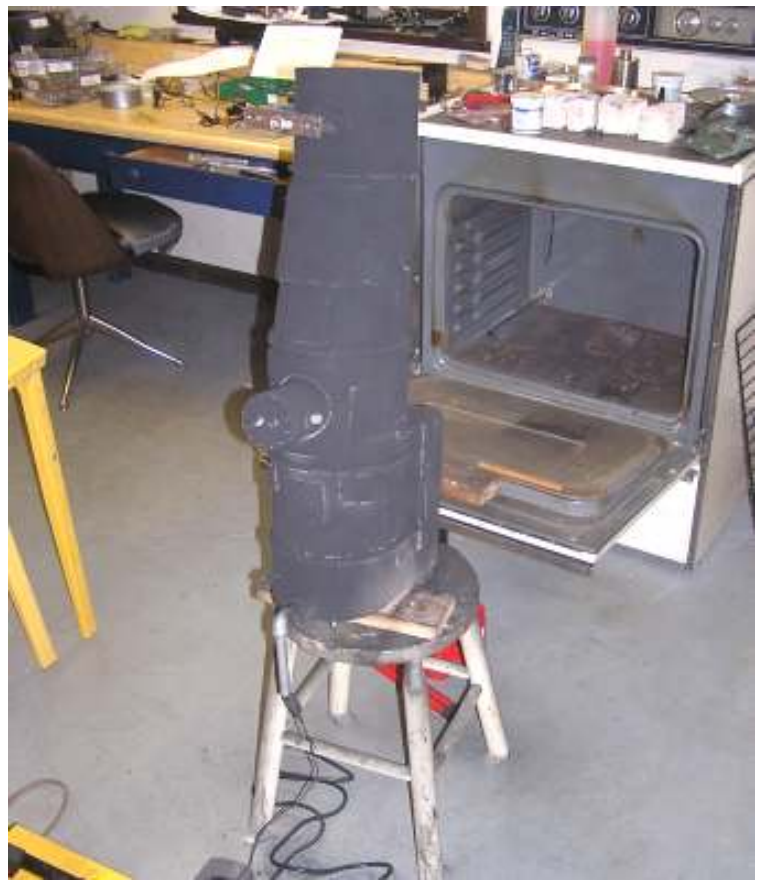
Painting Boiler: The first step was to give the boiler a quick final blast and then set it in the backhead and spray on the powder. I did this in front of the oven and then swept up any that fell to the floor. I also turned off the furnace and house ventilation to keep the stuff out of that system. Don't need to explain black dust all over the house.

After the front end and under side were powdered with the boiler upright, it was turned to the normal horizontal position with the smoke box end on the oven door. The powder was then sprayed on the back part of the boiler and the backhead. This photo shows the boiler after some more powder was sprayed, and the boiler slid part way into the oven. Note the thin areas on the rear side of the jacket spacers. More powder was sprayed so that everything was covered.

That is a handle in the front screwed on a threaded rod that is secured to a plate in the smoke box. The plate is held to the top of the smoke box with a couple screws through the smoke stack mounting holes. The threaded rod extends through the bottom of the smoke box to form a leg for the front. The rear handle is a couple nipples and an elbow screwed into the steam turret hole.

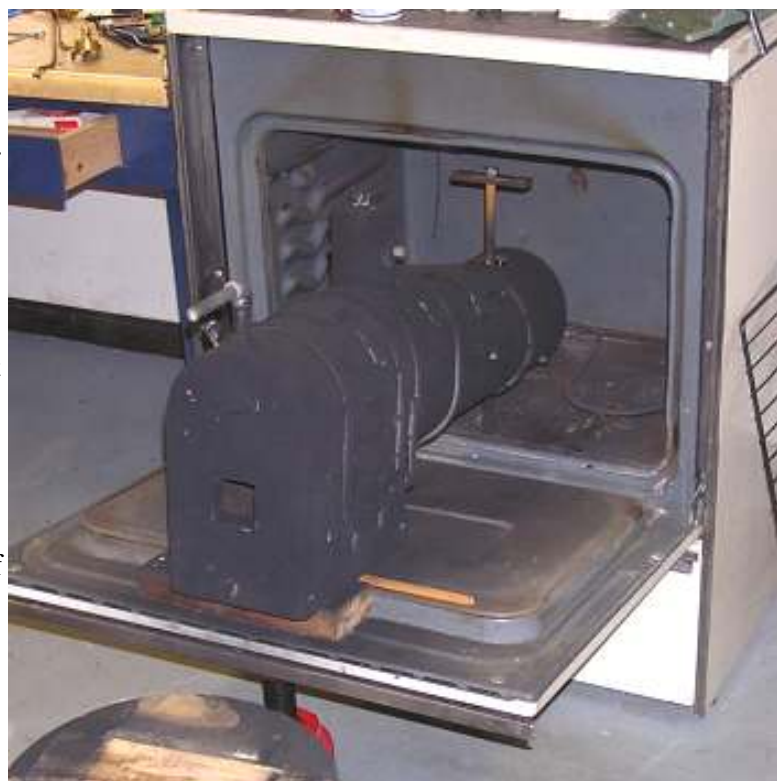
The anticipation was much like waiting for the Thanksgiving turkey to cook (or possum, if you're from that part of the country). Note the support under the oven door. The 20 ton jack was a bit of overkill, but it was handy.

The baking took a couple hours since the boiler has considerable mass. The smoke box part flowed fairly quickly but the backhead took over an hour to flow as it was the furthest from the burner.

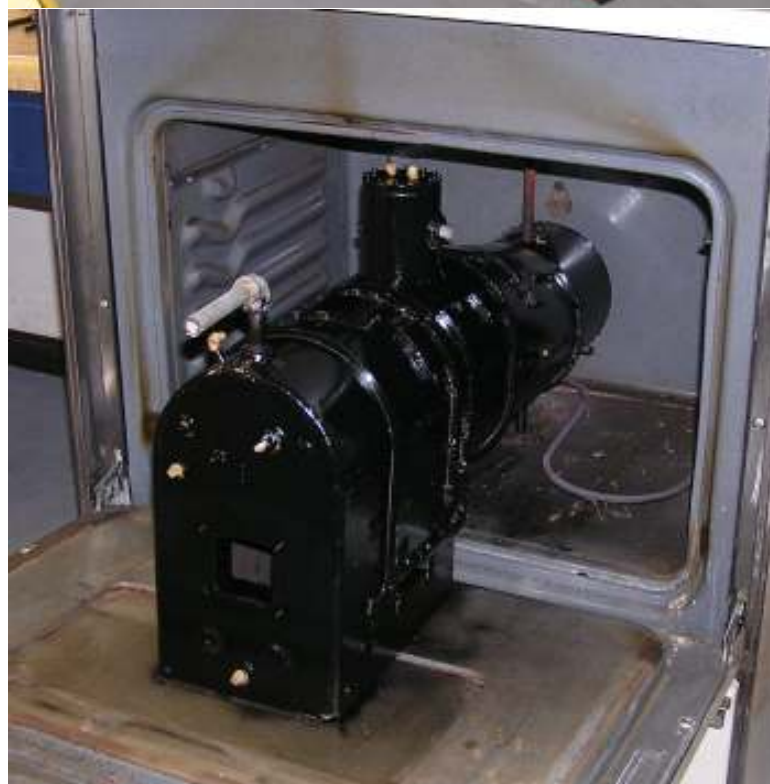
After a day of reflection, the smoke box was stripped (stripping the powder coat is no fun), blasted to get a good clean surface and it was then recoated. This time care was taken to keep the maximum temperature swing to below 400 degrees and the boiler was kept in the oven for only 20 minutes after the powder had flowed. The results this time was very nice--- glad I took the effort to redo it..

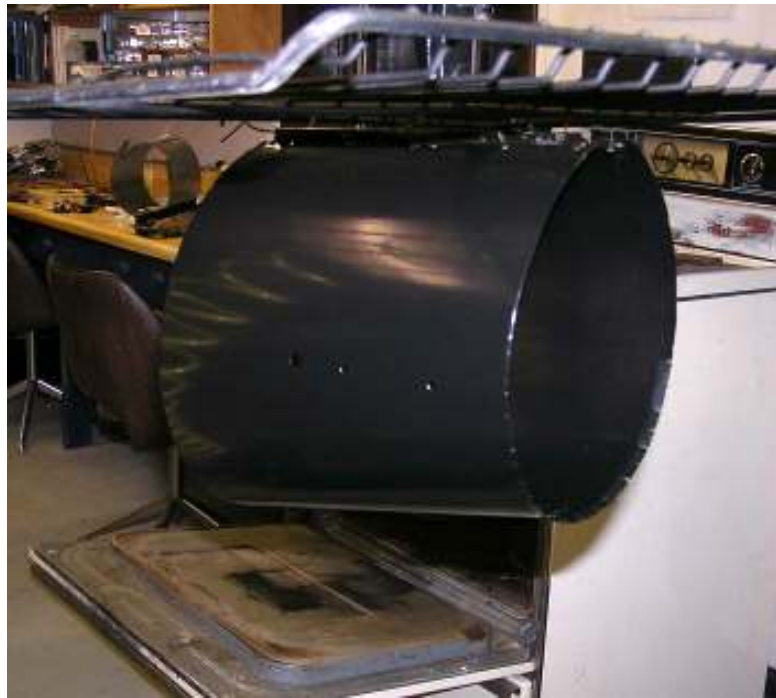
Painting the Jacket & Bands: The black stove pipe used for the jacket came with a painted surface --- I had thought it was an oxide coating. In any case, the paint was stripped using the cheap Wal-Mart stripper. The pieces were lightly blasted to remove any residue and to roughen the surface a bit. The photo shows the sloped jacket section hanging to cool after curing. The other jacket pieces and the bands were also powder coated.

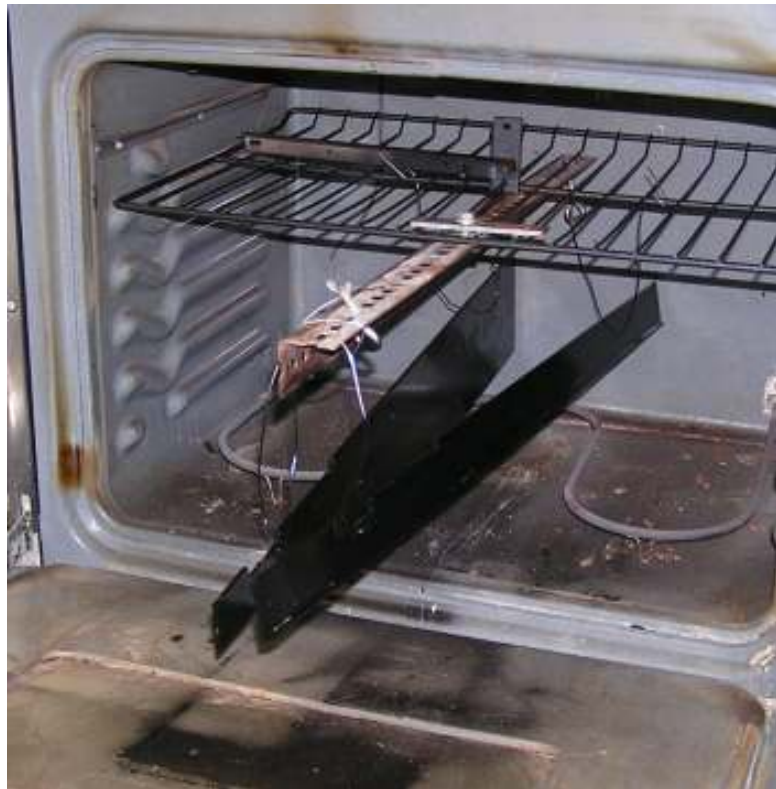
Painting the Walkways: The clamps that secure the rear boiler mounts clamp over the walkways too, so the walkways were also painted at this point so that the boiler could be mounted permanently.

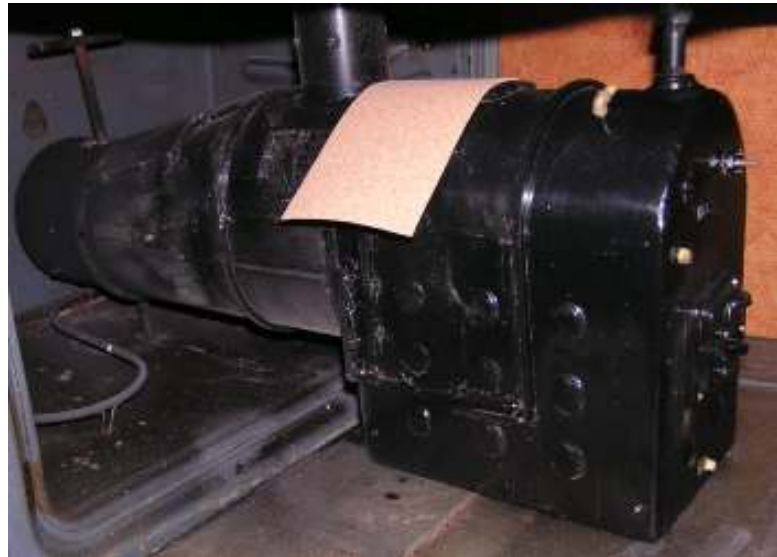
The cork offers some insulation value and a fairly firm base for the jacket so I decided to use the cork. I had a few sheets of varying thicknesses on hand and a quarter inch thickness will easily be achieved using multiple layers. Maybe can sell that other stuff to the brother-in-law.

Cork Test: I had been thinking about the lagging while preparing the smoke box area to be powder coated again. A piece of cork sheet was laid across the boiler while the smoke box area powder was cured. The temperature at the very back got to 300 degrees and the temperature at the front got to 375 degrees, so the cork probably made it to about 340 degrees. There was no noticeable effect on the cork.

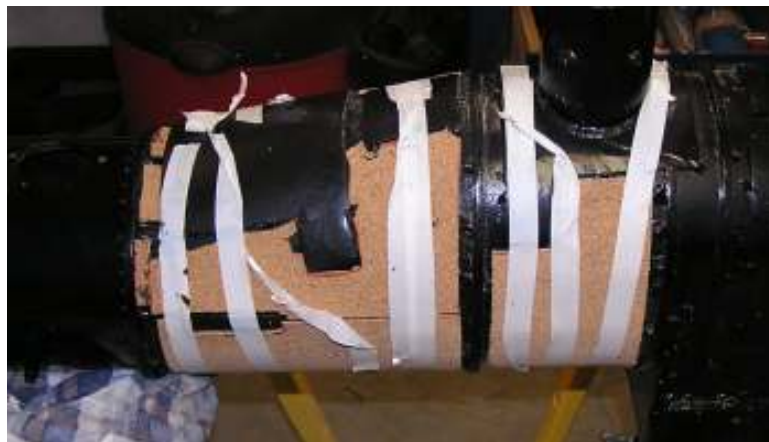
Had some 1/8" thick sheets so used two layers. The photo shows the first layer held in place with masking tap while the adhesive (Permatex No 2B) set.

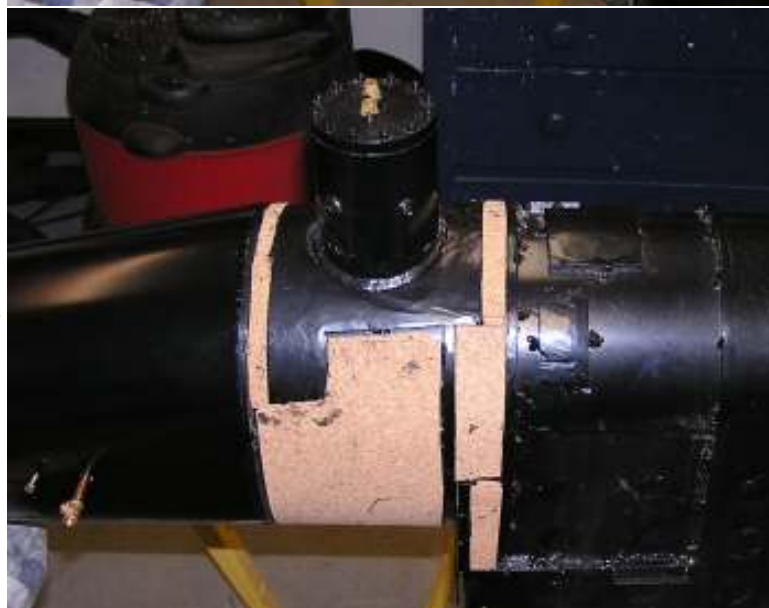
This photo shows the middle section after the second layer of cork was applied and the adhesive set. Note that the front jacket section is in position.

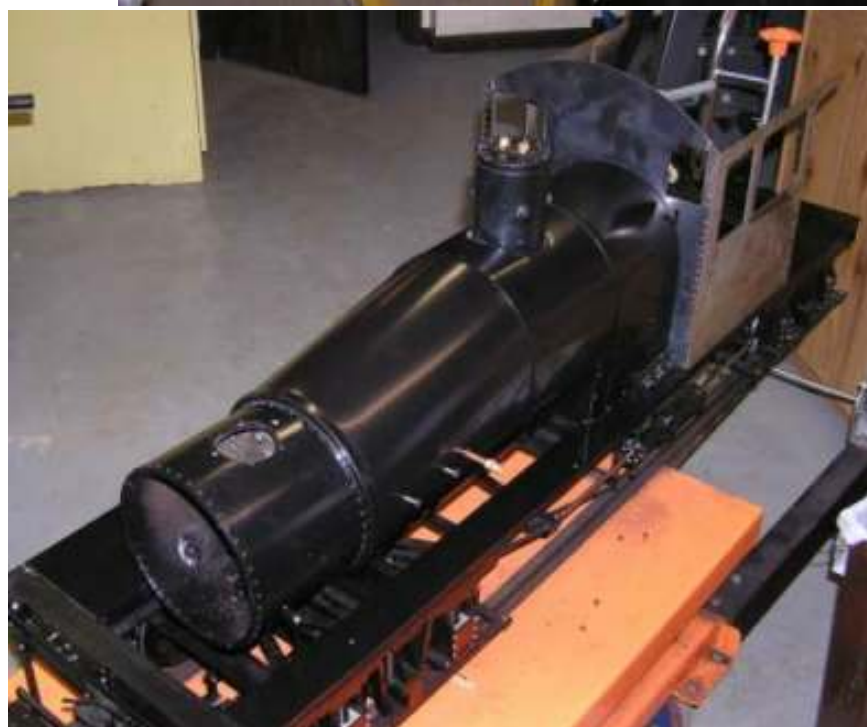
This photo shows the boiler with jacket and bands in position on the frame.
